DOT/FAA/AR-96/21

Composite Failure Analysis Handbook Update 1

August 1997

Final Report

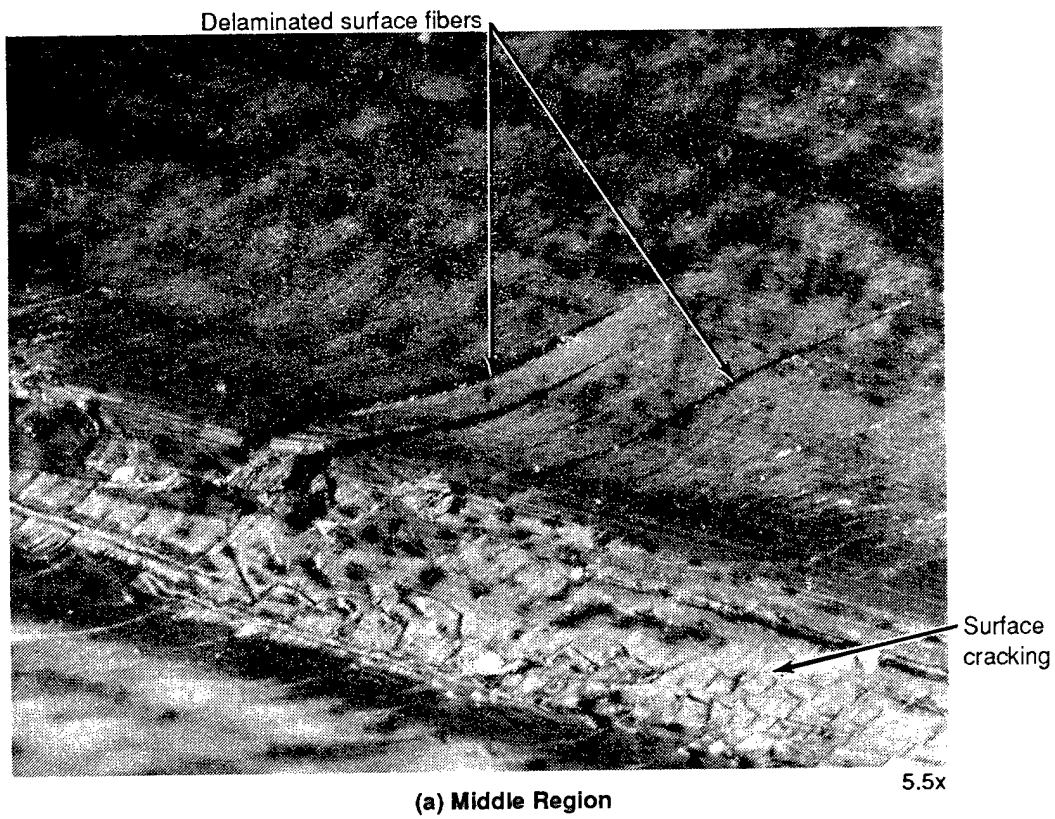
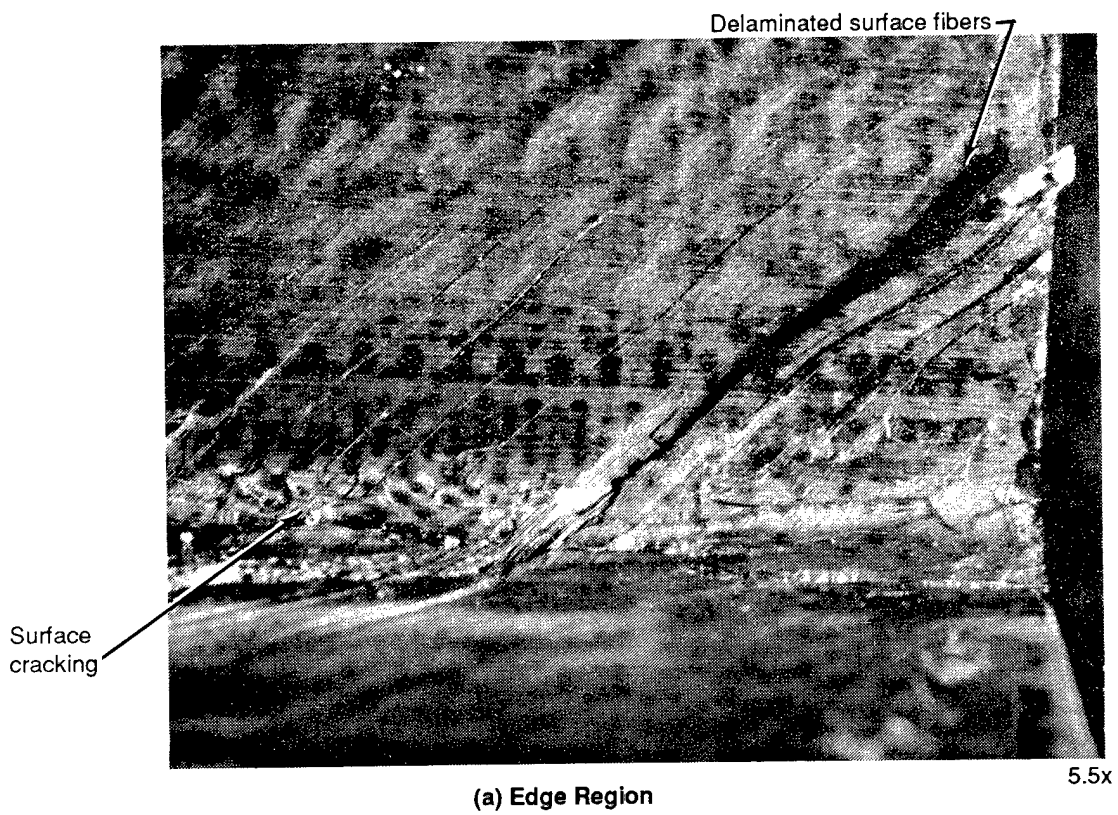
Surface fibers within the inner radius of the "knee" were cracked (fig. 4). Deformations, such as rippling and buckling, were also present along the entire length of the inner radius of the knee. Small indentations and elongated depressions or "tracks" were present along the inner knee surface (fig. 5). The surface of the depressions was shiny indicating that the depressions probably occurred during the fabrication process. Some of the "tracks" contained cracks which went through the surface ply. There were no surface defects or anomalies on the outside surface of the component. Strain gages were located on both sides of one of the flanges.

Figure 4. Micrographs Showing Regions of Surface Fibers Delamination and Cracking Along the Middle and Edges of the Inner Radius

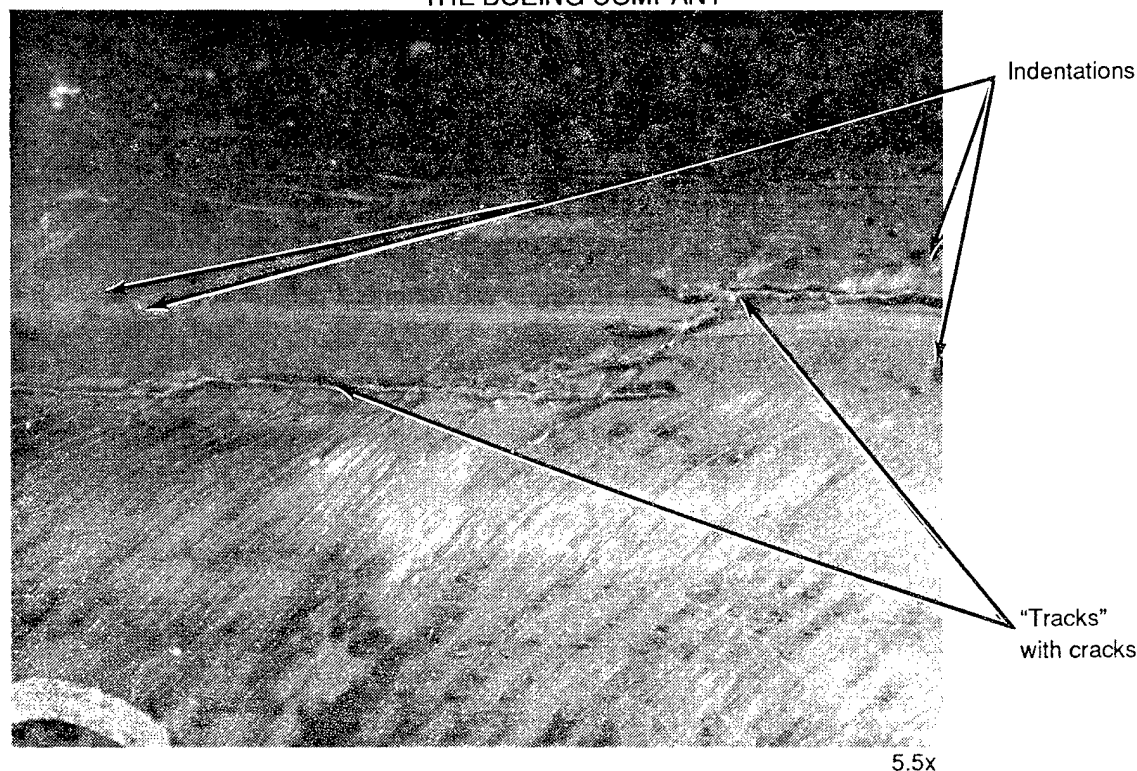
Figure 5. Micrograph of the Indentations and "Tracks" Along the Inner Radius

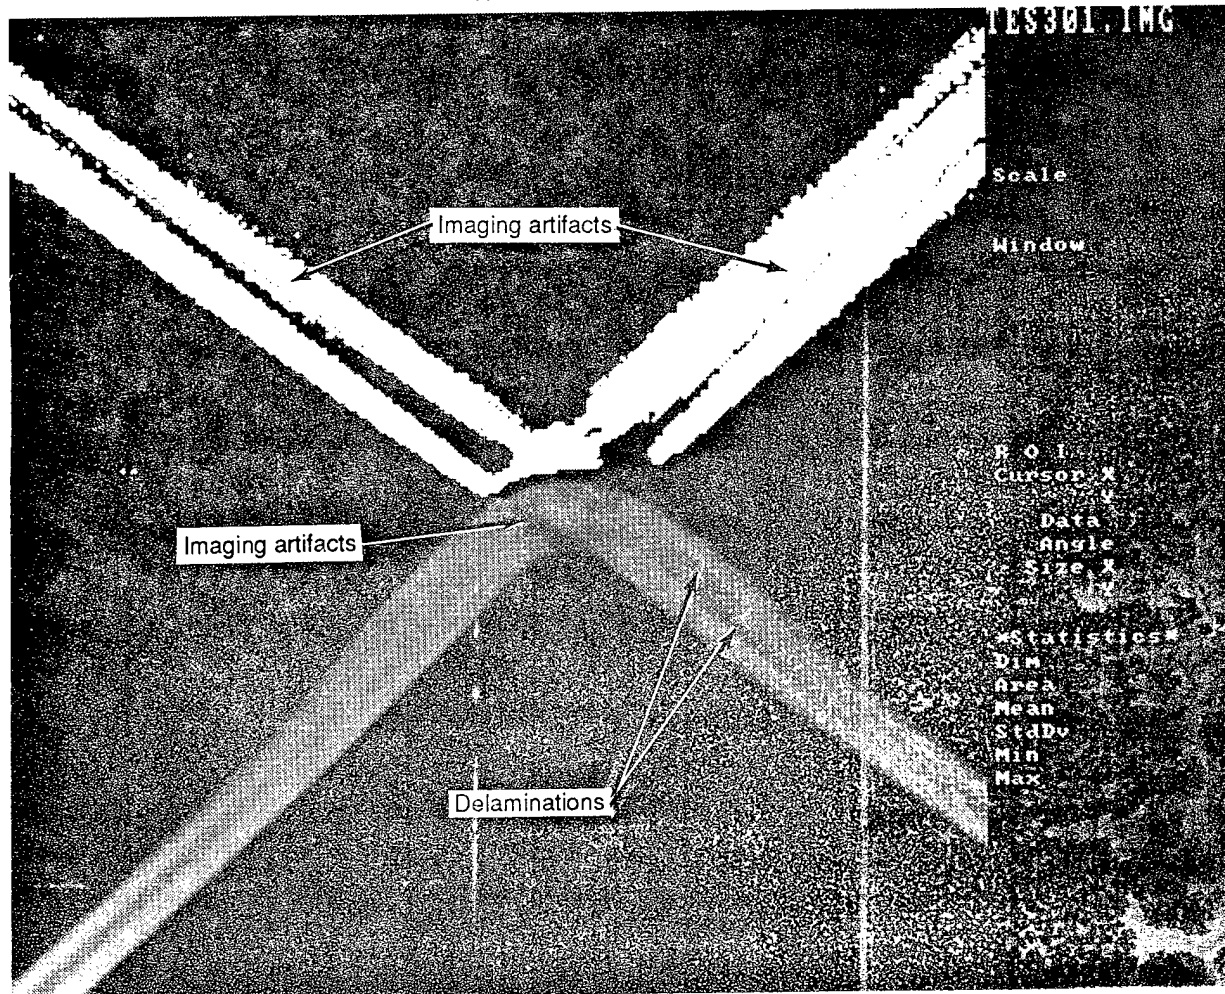
Figure 6. CT Image Showing the Imaging Artifacts and Some of the Actual Delaminations

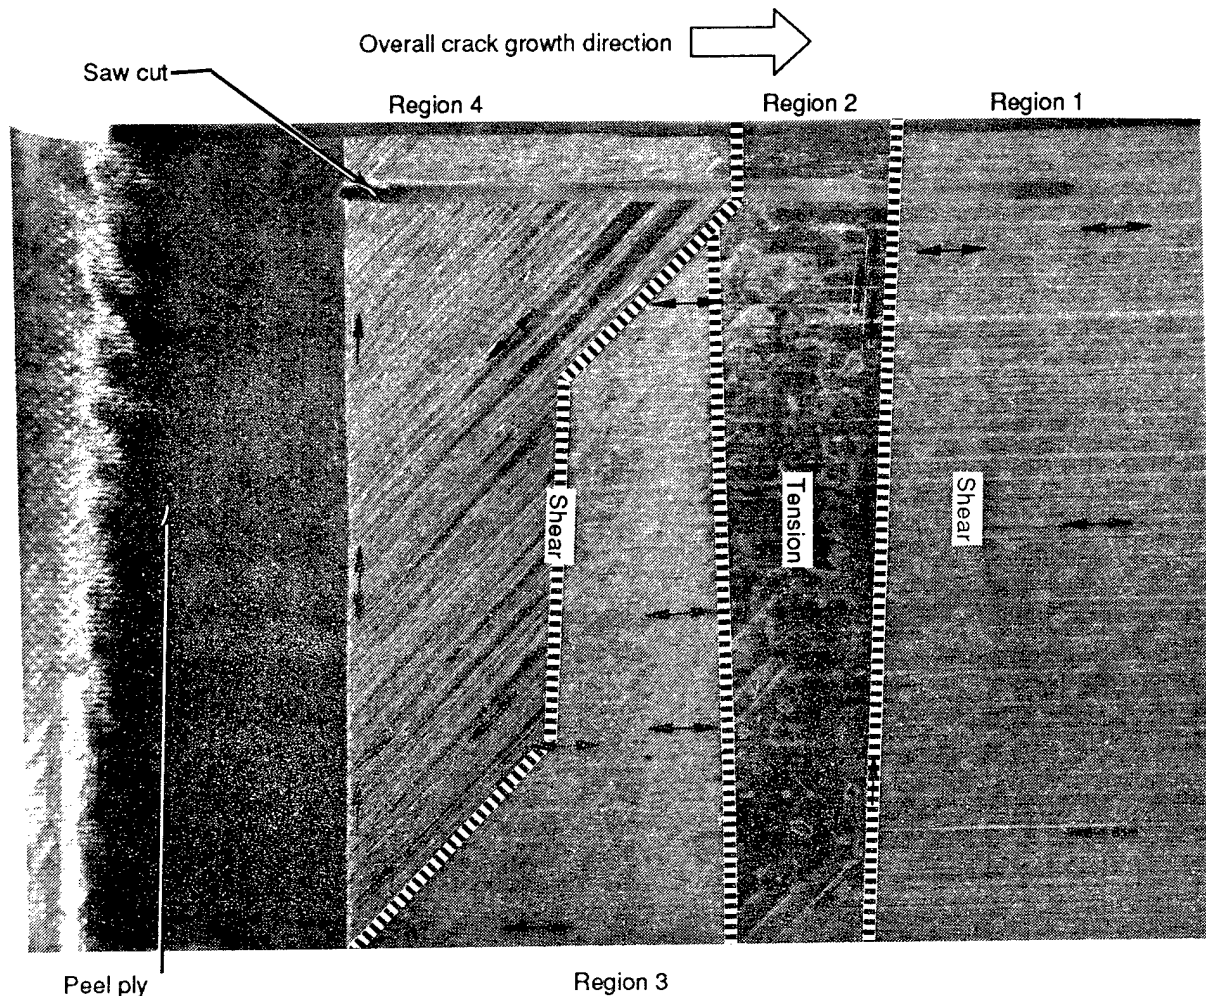
Initially, the component was gripped at the edges of the flanges using the fastener holes. As loading began, one edge was pulled away from the other edge which induced an initial shear loading condition inside the component at the edge of the peel ply. The presence of the peel ply in the center (where the maximum shear stress occurred) provided a high stress concentration region which allowed the cracks to initiate. As the edges were pulled further apart, the cracks continued to propagate by shear.

Note: Four regions are identified, exhibiting two different fracture modes:

- Region 1: Mode II (shear)
- Region 2: Mode I (tension)
- Region 3: Mode II (shear) 0-degree fibers
- Region 4: Mode II (shear) 45-degree fibers

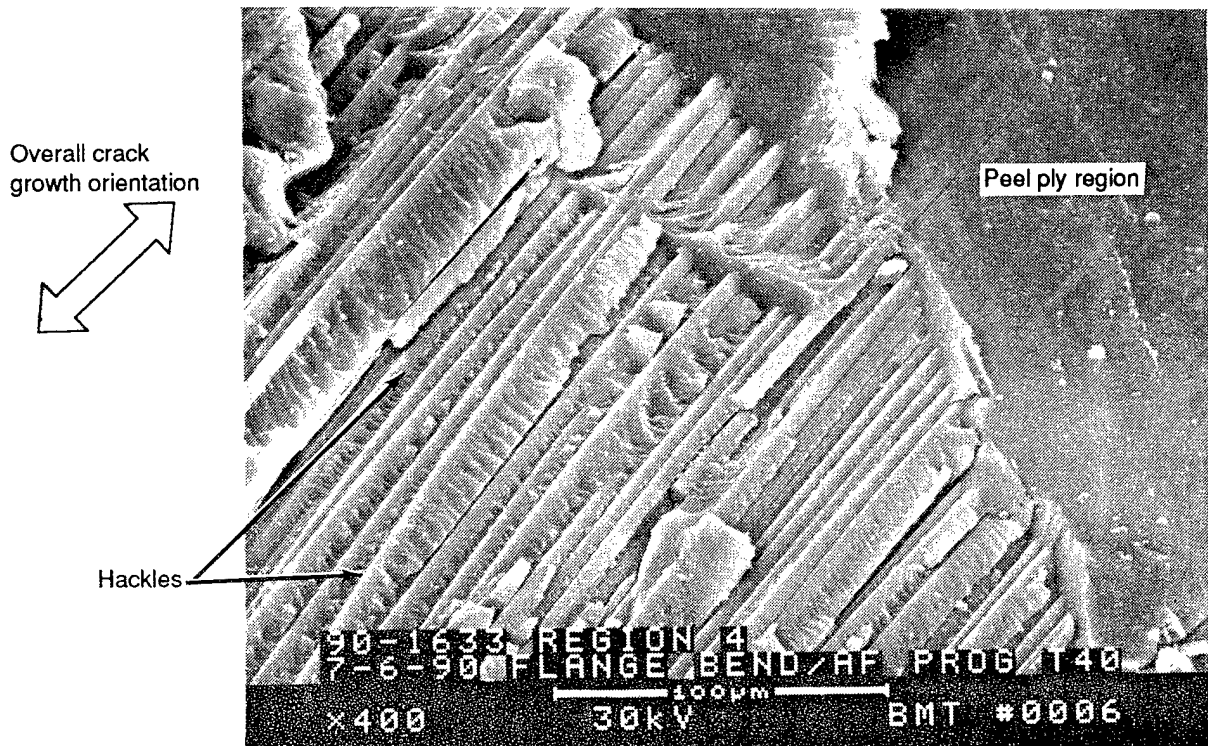
Figure 14. SEM Micrograph of a Mode II-Type (Shear) Fracture Surface in Region 4 Adjacent to the Peel Ply

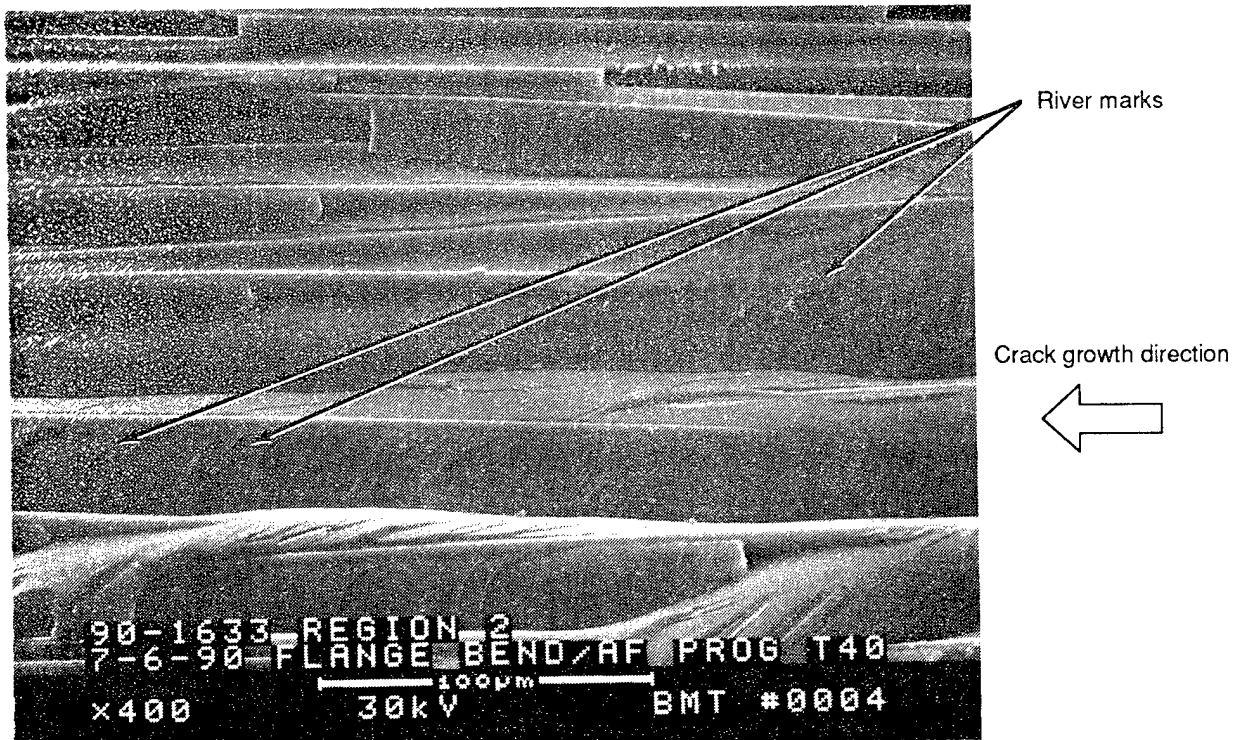
Figure 15. SEM Micrograph of a Mode I-Type (Tension) Fracture Surface in Region 2

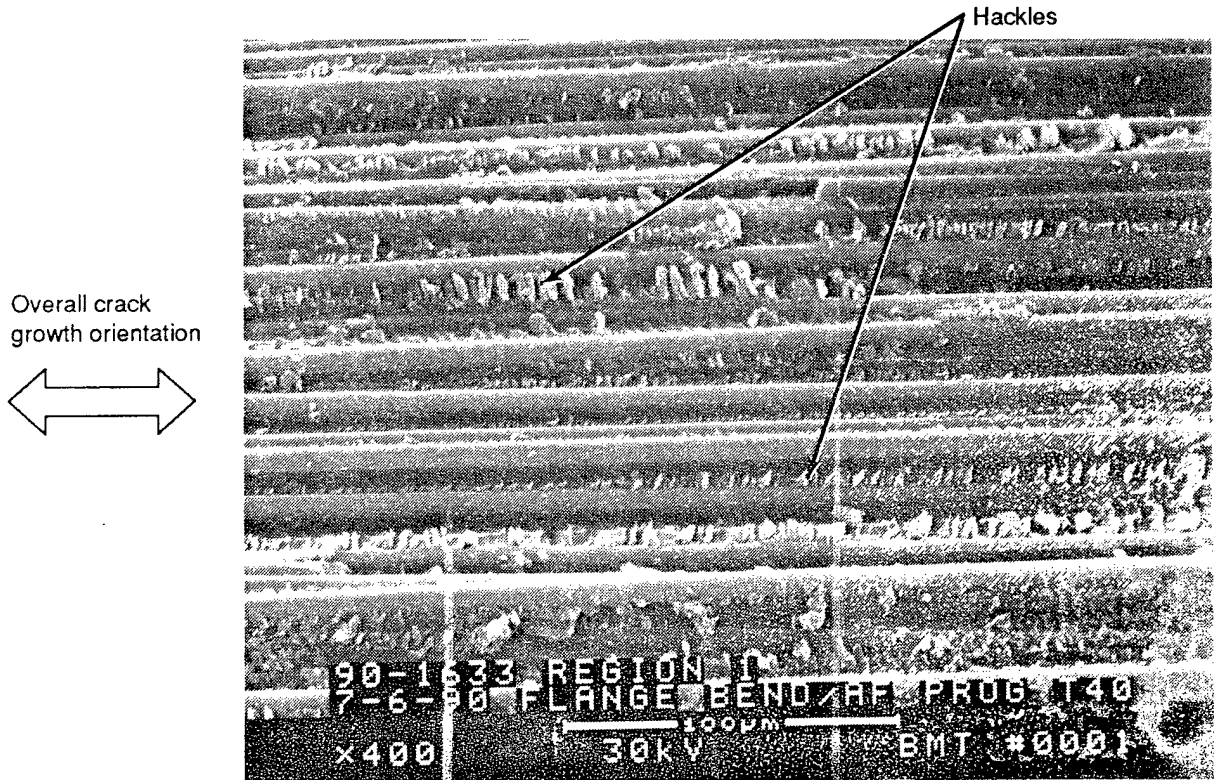
Figure 16. SEM Micrograph of a Mode II-Type (Shear) Fracture Surface in Region 1

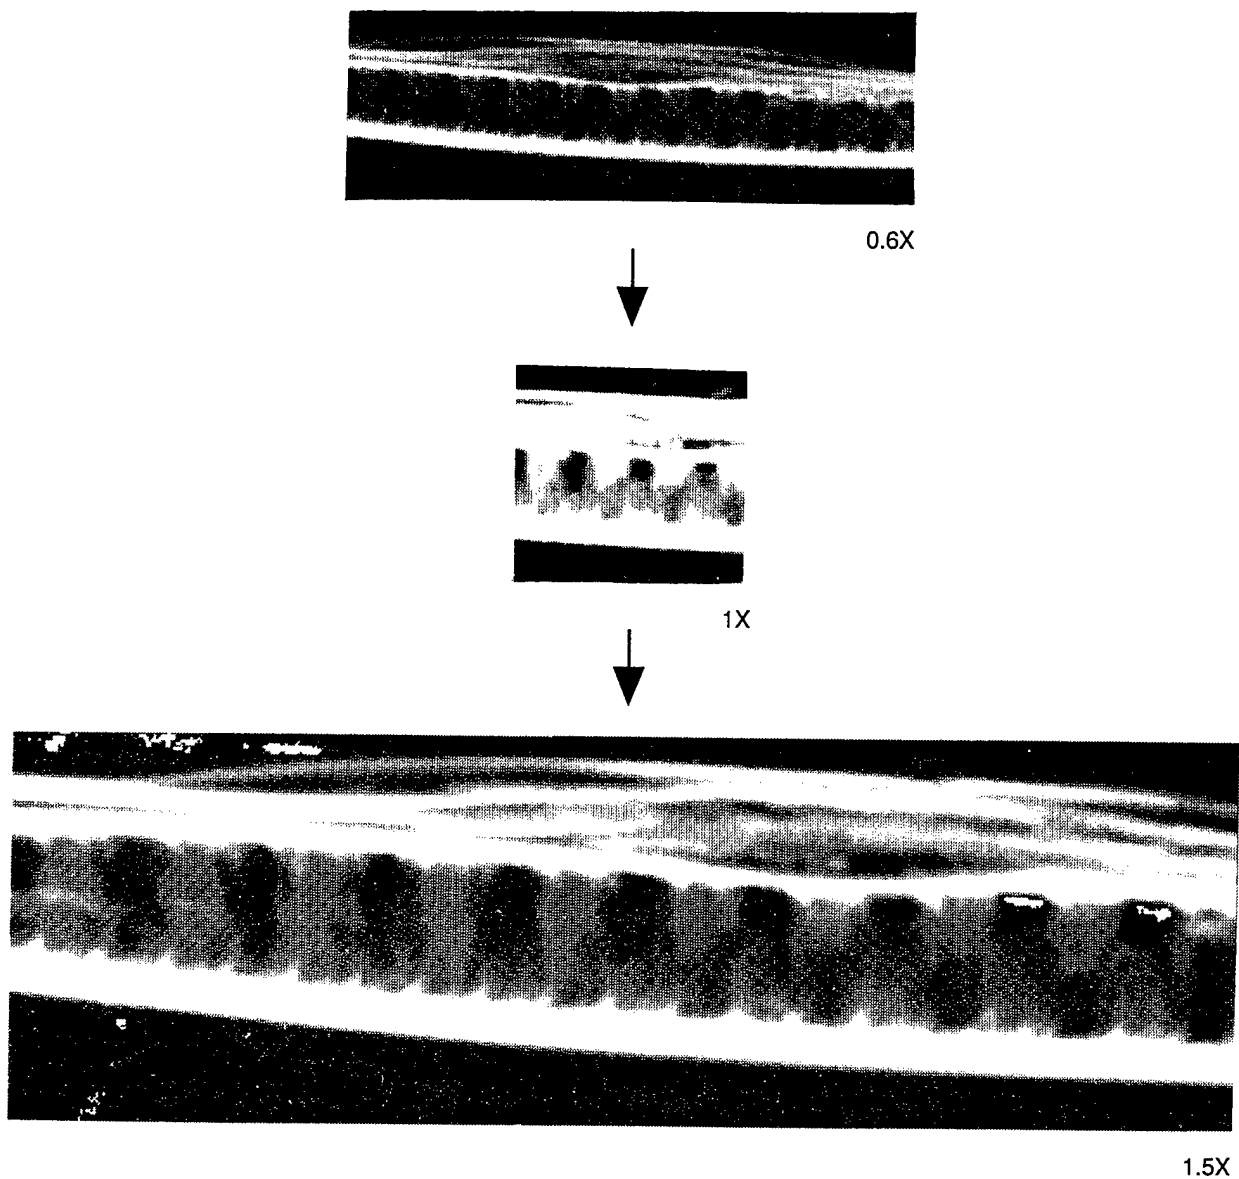
Figures 8 through 11 through show the various images of the slices through the component. The longitudinal slices 1, 2, & 3 show the damage present in the honeycomb regions in the center of the component. The front half of the panel appears to have been crushed by a macroscopic shearing of the upper front half of the facesheet. The back half exhibited little if no damage. However near the bulge, the core appeared to be crushed in the short transverse direction. There was no evidence showing any longitudinal buckling trends to either end (from one end to the other). This transverse damage was located all along the back half of the component.

Figure 8. CT Images of the Transverse Scan Through the Delaminated Zone

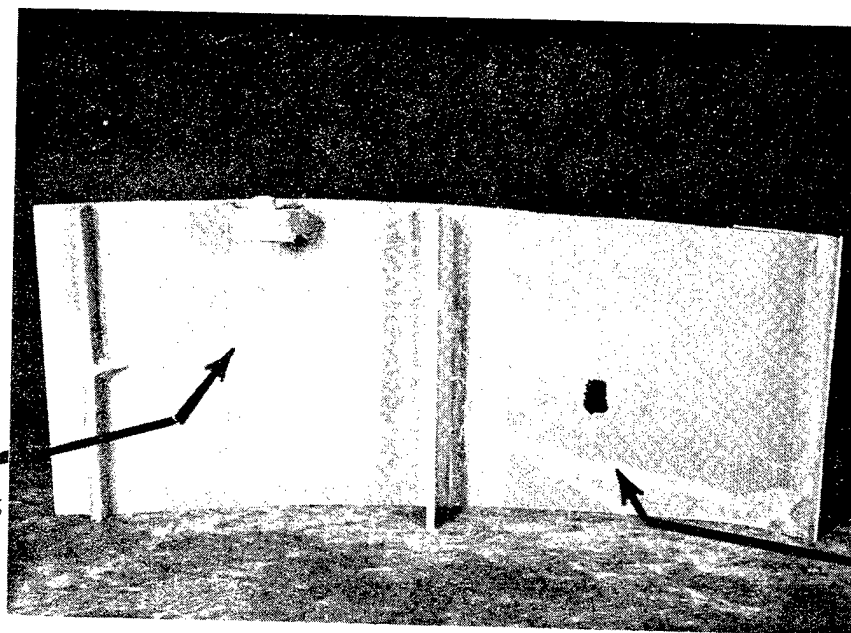
large delaminated
region corresponding
to a sanded region
on the outer surface

Figure 3. Photograph of the Inner Surface of the Upper Wing Surface

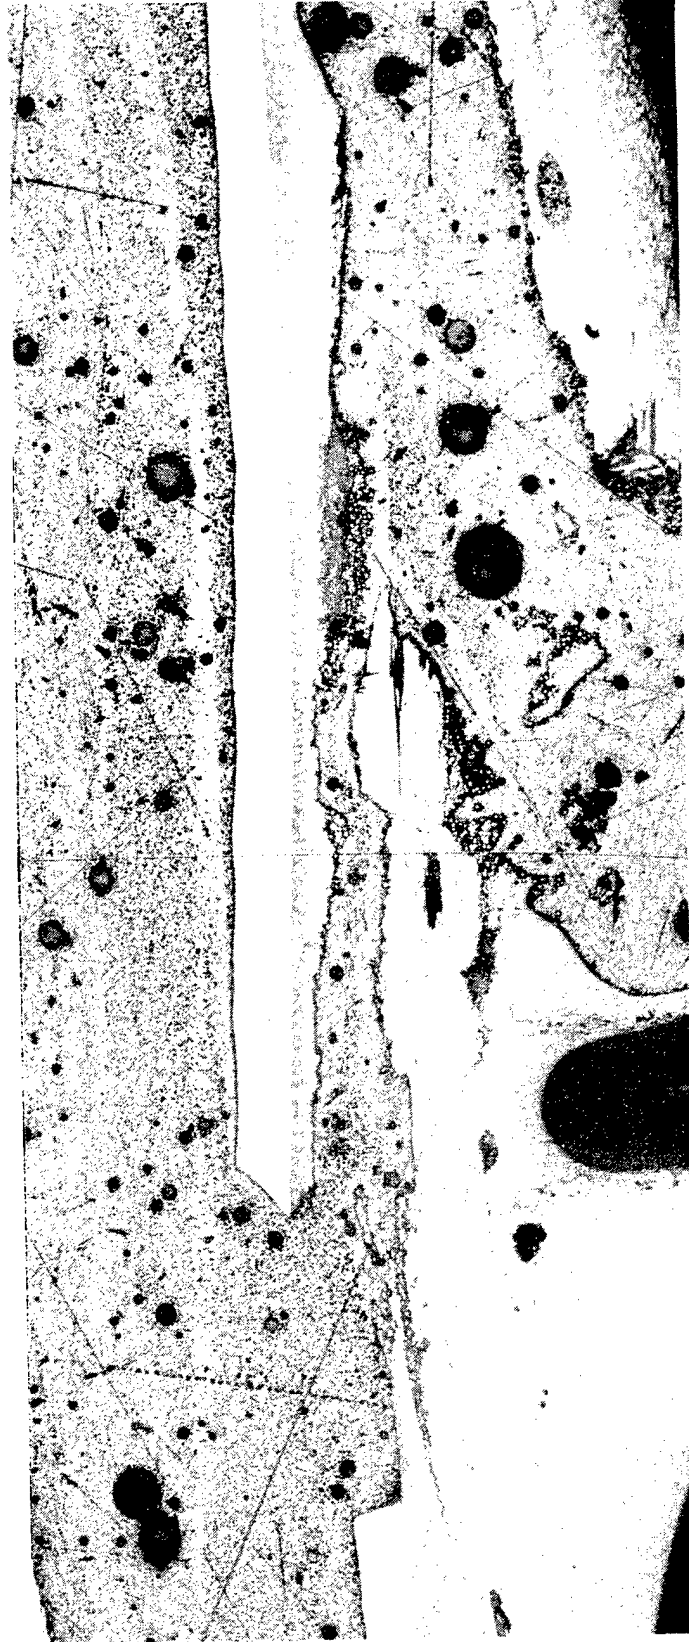
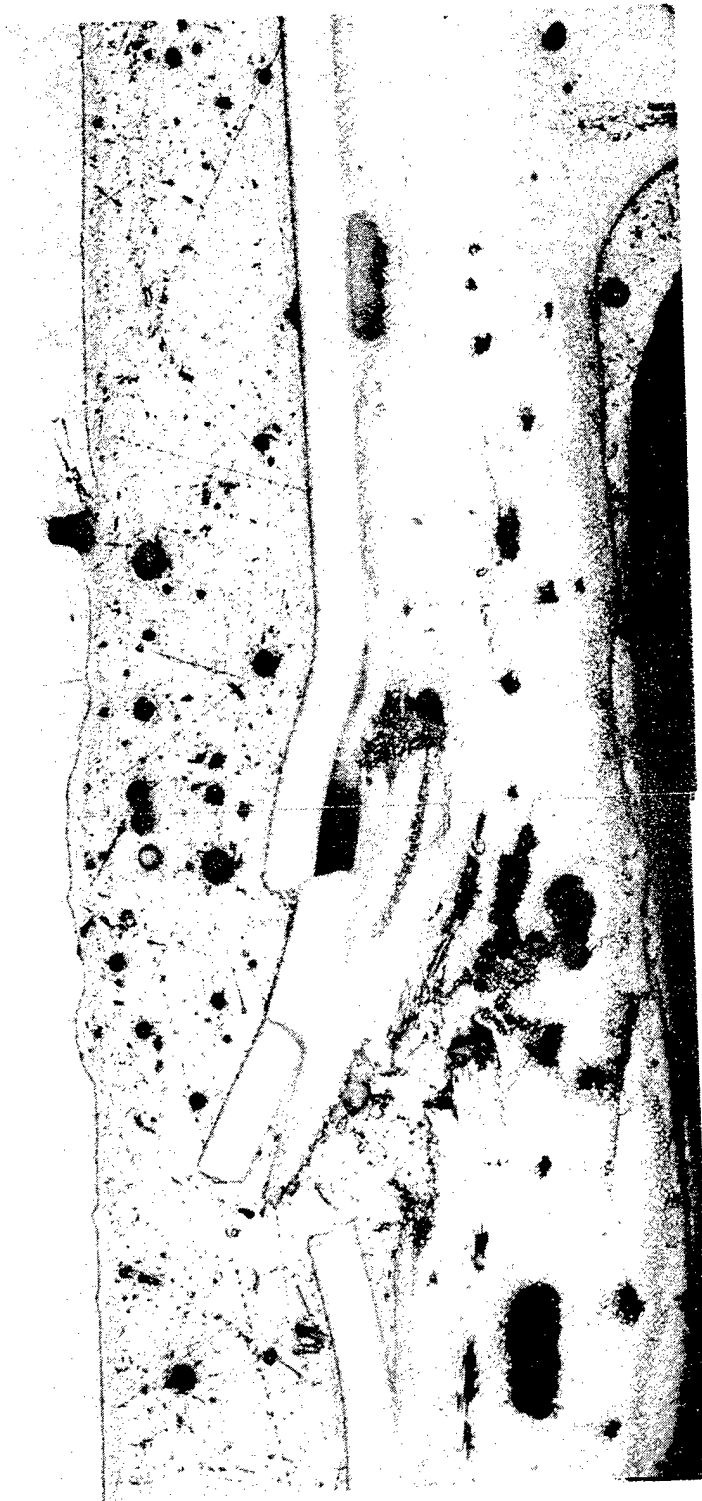
Figure 11. Cross Section through a Crack in the Upper Wing Skin

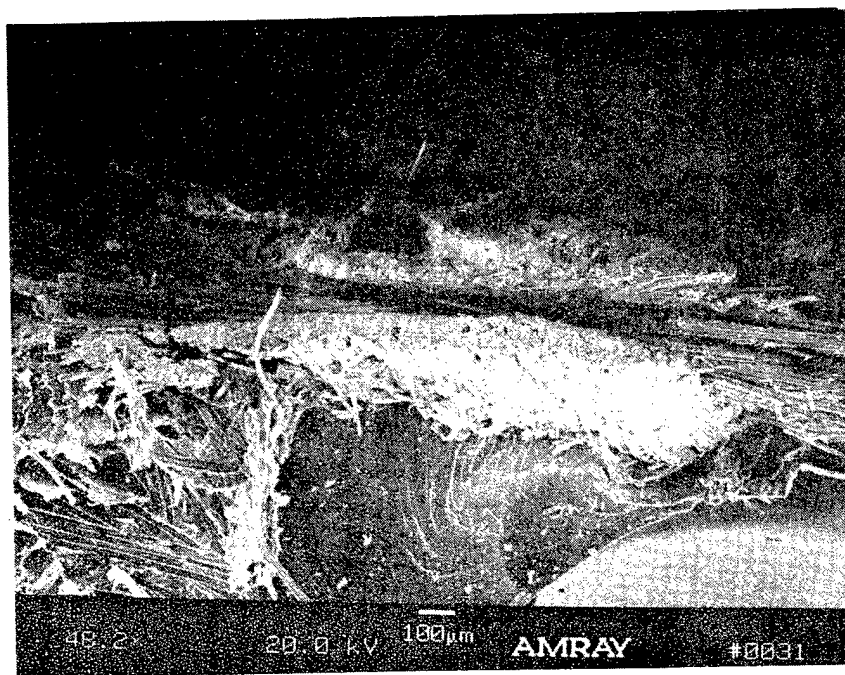
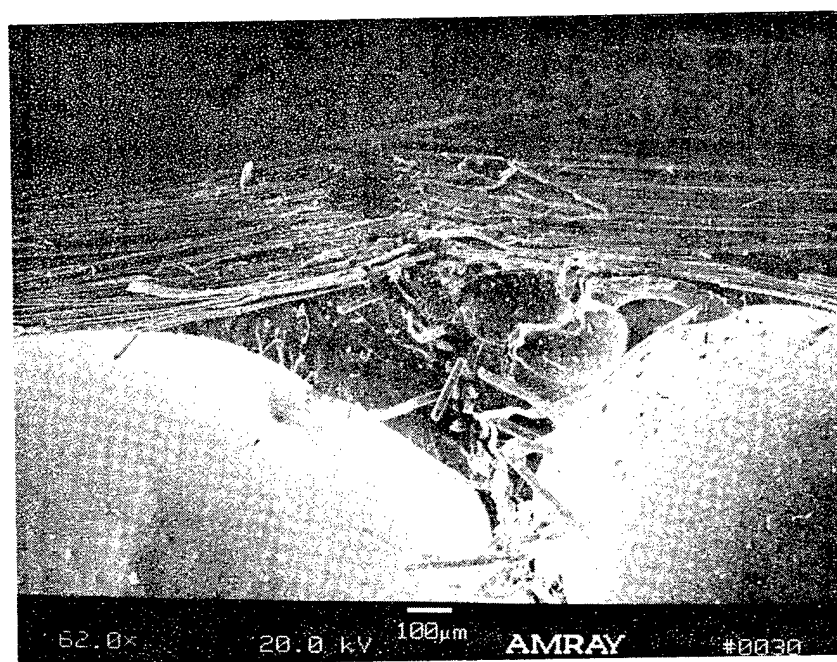
Figure 12. SEM Photographs of the Crack Surfaces

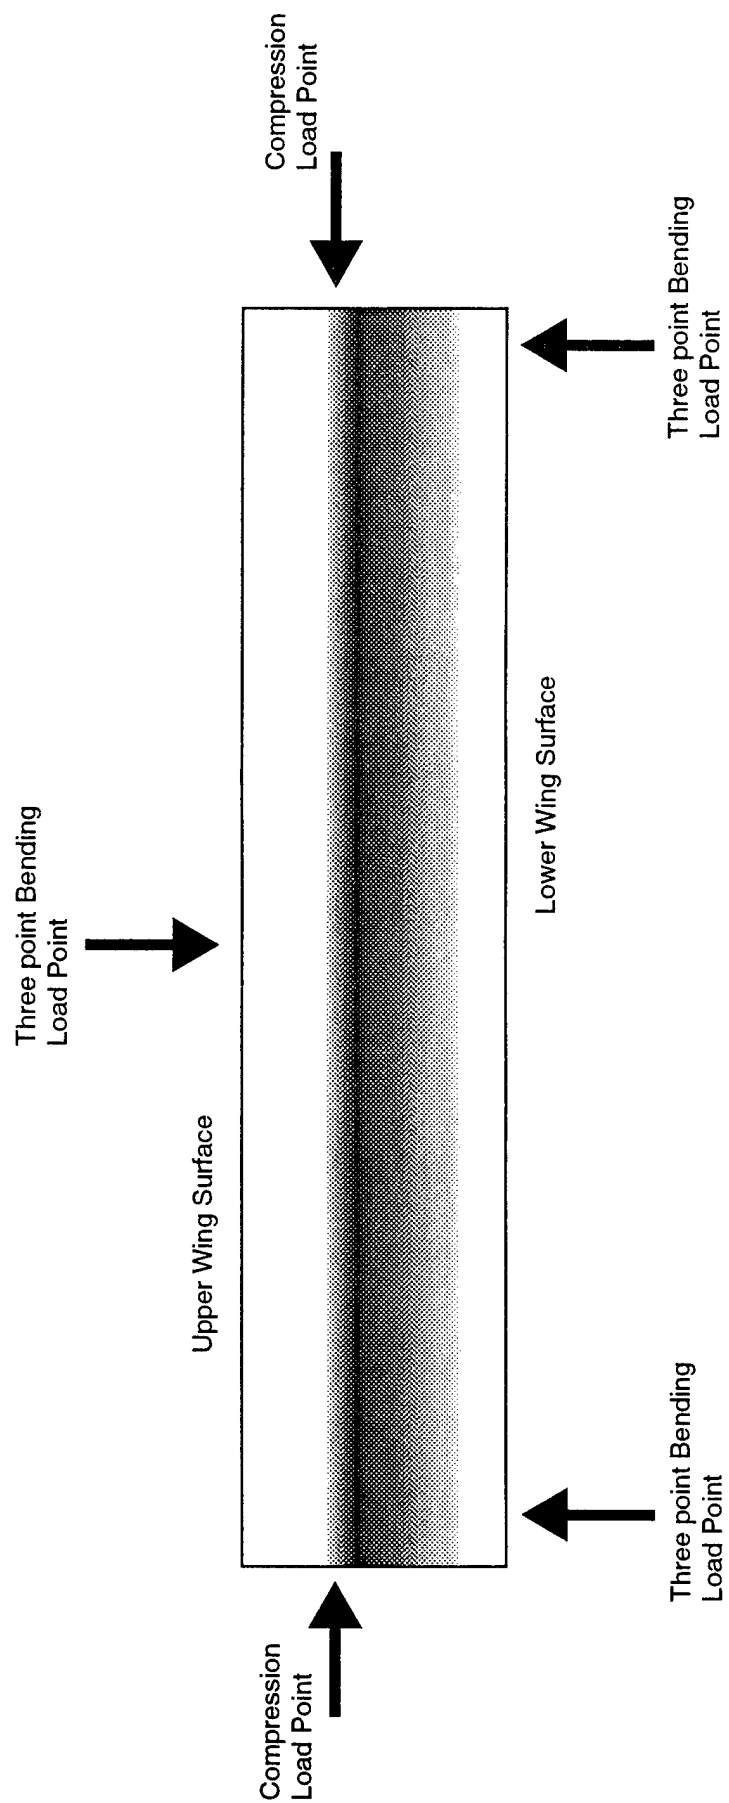
1. The wing section contained two major cracks which extended from the leading edge of the wing to the aft edge. Another small crack was located at the edge, in the middle of the wing section. All of the cracks were on the upper wing skin.
2. Chemical analysis of the materials did not reveal any anomalies in the materials. No material or fabrication anomalies which could have contributed to crack initiation were found.
3. Cross-sectional and SEM analysis revealed the fractures were caused by buckling of the upper skin. The specific cause of the bucking could not be determined.

Figure 13. Diagram of the two Proposed Loading Configurations Which could Cause the Upper surface to Buckle
